Roof and Rain Water Drainage System Maintenance Report

Date:	11/25/2020
Address:	XXXXXXXXXX XXXXX
Inspection No:	113
Type:	Residential
Client:	XXXXXX XXXXXXXXXXXX XXX

Section 5: Details of completed works

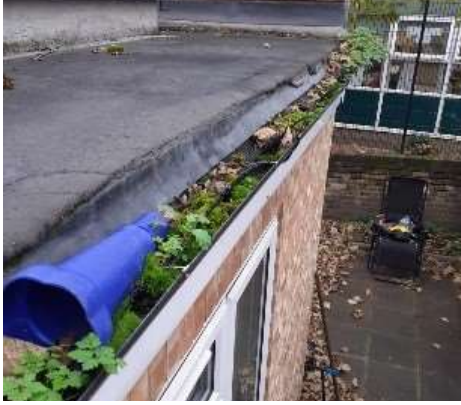
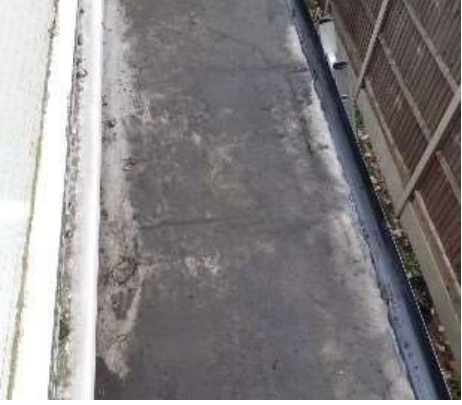
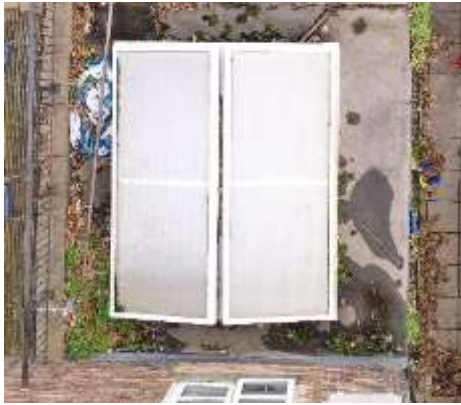
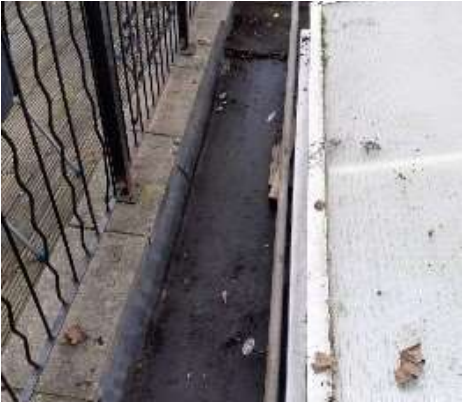
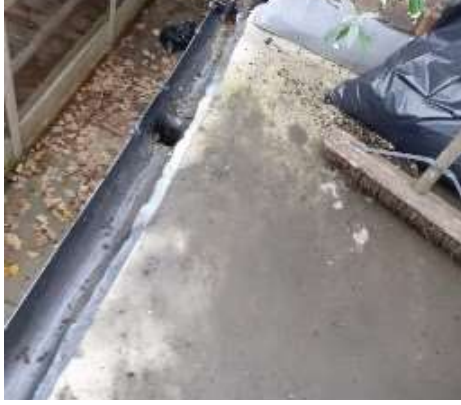
<p>A</p>	<ol style="list-style-type: none"> 1. Cleaned gutter from debris and vegetation. 2. Cleaned and cleared the flat roof of the rear extension from debris and vegetation. 		
<p>Photo 1</p>

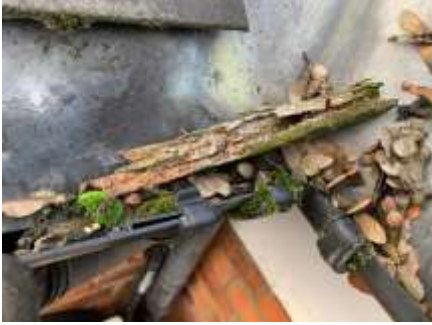
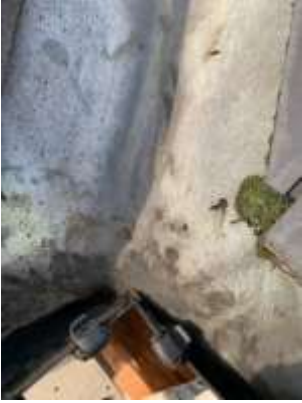
C	1. Cleaned gutters from debris and vegetation.		
	Before	After	
Photo 1

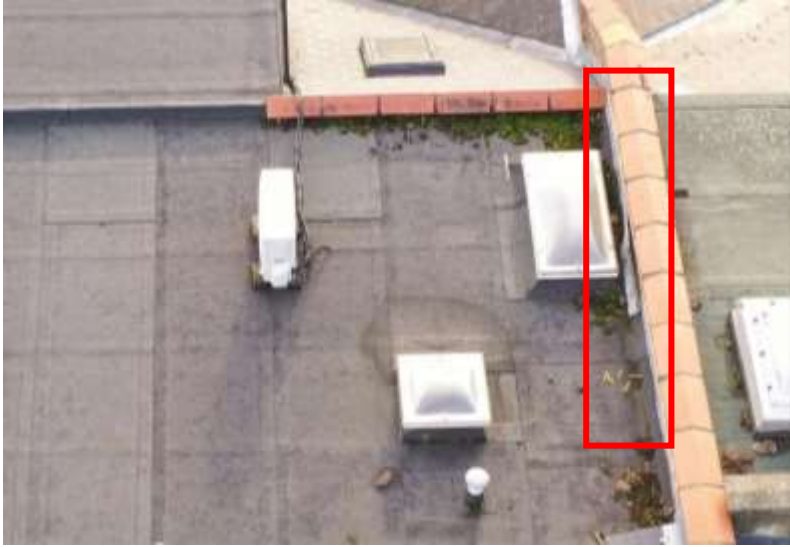
D	Lead flashing is coming off from the connection points from the wall. The mortar/sealant is chipping off and will cause water penetration	3
Fig. 1

- D. Remove the loose flashing from the wall, check the condition of the flashing, replace if needed and reset back to the wall using high-quality mortar/sealant.
- E. Remove part of the lead flashing that is obstructing the flow of water in order to restore full flow into the gutter.
- F. Supply and fit new roof tile with matching tile
