Roof and Rain Water Drainage System Survey Report

Master Property Care Ltd

Date:	3/8/2021
Address:	XXXXXXXXXXXXXXXXXXXX
Inspection No:	125
Type:	Residential-Commercial
Client:	XXXXXXX XXXXXXX XXXXXX

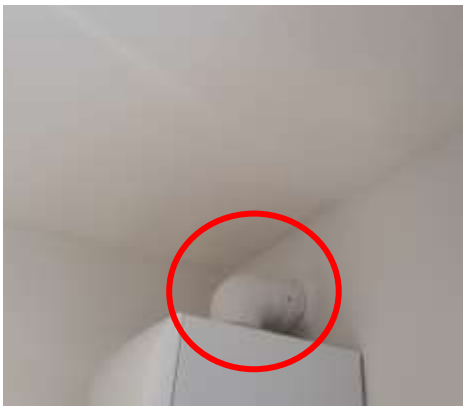
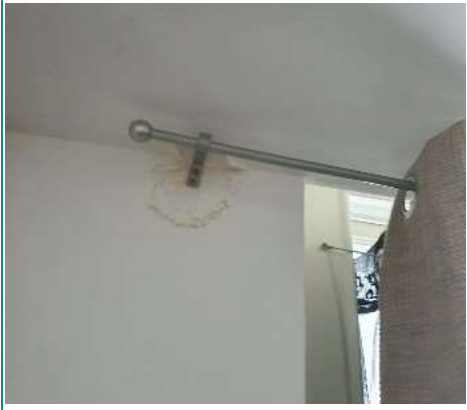
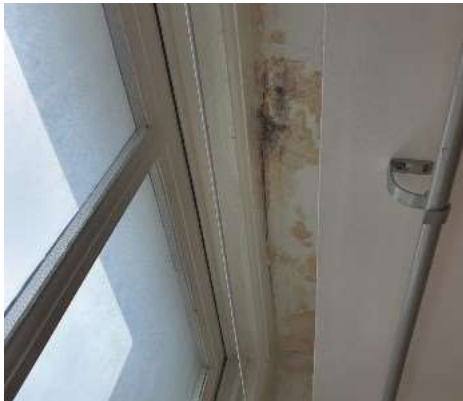
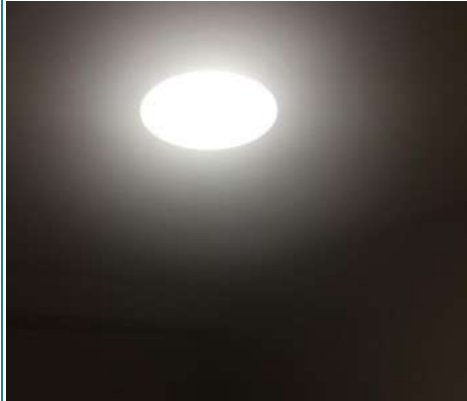
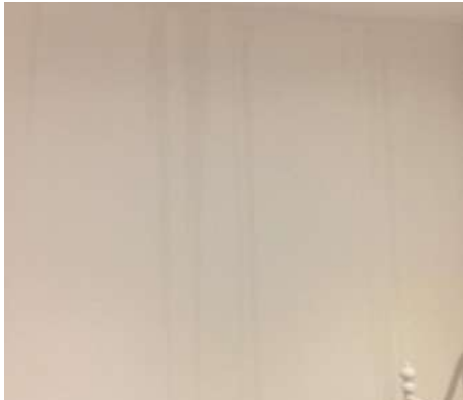
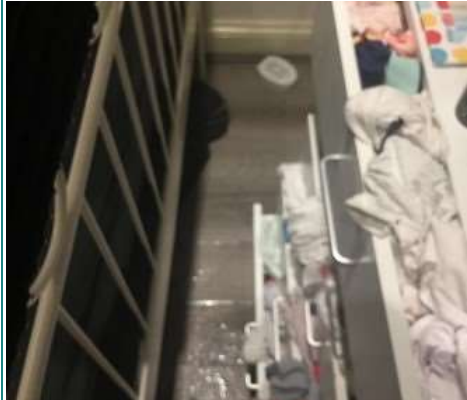
<p>VIS. A</p>	<p>The tenant complained of a leak during rainy weather in the bedroom. Upon inspection, signs of water penetration at the bedroom ceiling on the window's side of the room with watermarks around the spotlights. (photos 1,3,4,5,6) A section of the ceiling by the window frame has signs of severe mould and penetrating dampness. (photo 2)</p>		<p style="text-align: center;">3</p>
<p>Photo 1</p>

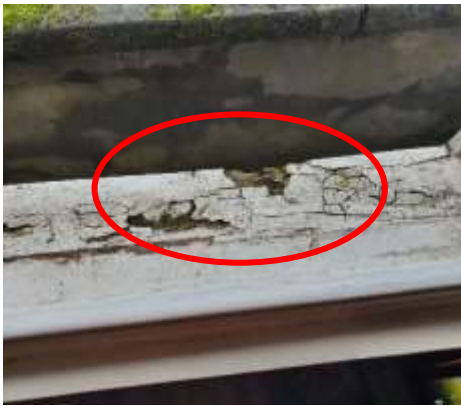
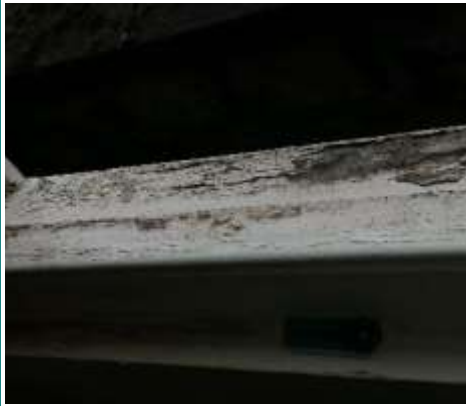
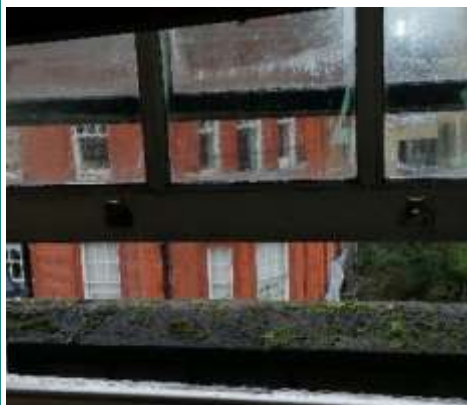
<p>VIS. D</p>	<p>The rotten and damaged timber window frame in the living room above the bedroom of xxxxxx is likely to be one of the causes of water penetration into xxxxxx (photo 1,2).</p> <p>Timber windows in poor condition (photos 3,4).</p>	<p style="text-align: center;">3</p>	
<p>Photo 1</p>

Location	Ref	Recommendation	Page	Priority
<u>XXXX</u>	1	Box-gutter needs to be redone and raised to create a wider box-gutter	9	3
	2	The front elevation of the mansard roof will need to be removed entirely and redone to create a wider box-gutter		
	3	Timber sash windows need to be replaced	8	3
	4	Scaffolding and license are required for any works that are to be carried out

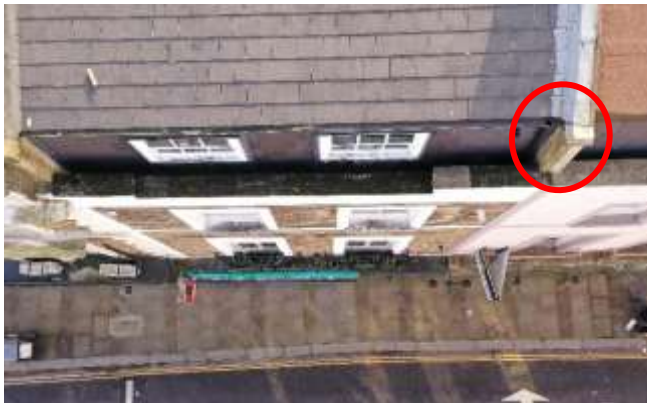
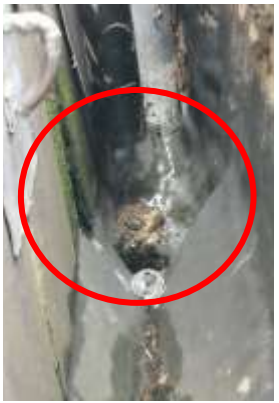
<p>DRO. 1 (F)</p>	<p>The box gutter located on the right side of the neighboring property is also draining into the same downpipe. It may not be sufficient to accommodate a large flow of rainwater from both properties and may cause an overflow responsible for water penetration into xxxxx. (photos 1,2).</p>	<p style="text-align: center;">3</p>
<p>Photo 1</p>

Location	Ref	Recommendation	Page	Priority
<u>xxxxx</u>	1	It is important to consider that the box-gutter from the neighbouring property is draining into the internal downpipe of this property. Therefore, if the cause of the leak into xxxx is not sufficient for the drainage system of both properties and due to this there is an overflow of water and flooding into xxxxx, then the cost of these repairs could be shared between the landlords of both properties or the owner of next door need to consider to redirect the drainage from his roof and box-. gutter	10&13

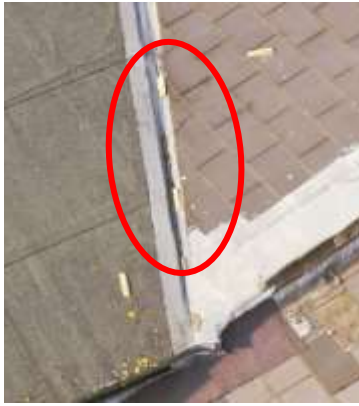
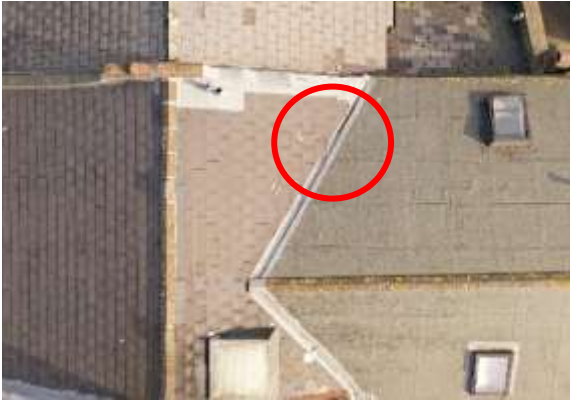
<p>DRO. 2 (VIS. G)</p>	<p>Tenants pointed out a leak in the hallway where we identified signs of watermarks on the ceiling and some penetrating damp (photos 1,2). We have identified the damaged valley, a possible source of the leak in the hallway of xxxxx.</p>

Location	Ref	Additional Recommendation	Page	Priority
<u>External</u>	1	To fix the roof valley	10&14	3
	2	To clean the box-gutter and gutters	15	3
	3	To re-bed the ridge tiles	16	3
	4	To cover the roof with new felt or for long-lasting repair to cover the roof of the back extension with new OSB boards and EPDM rubber roof covering	16	3
	5	Investigate a crack in the external rendered wall on the left-side elevation from the property's Church Rd standpoint	16	3

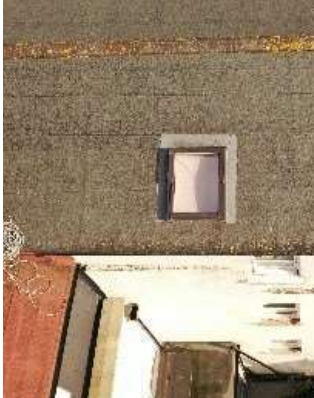
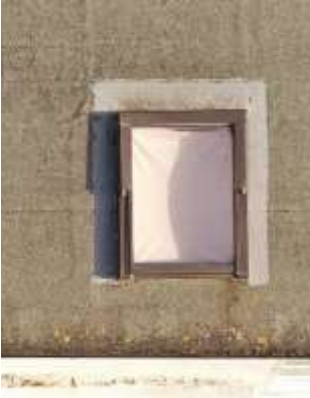
<p>DRO. 3 (VIS. H & L)</p>	<p>Tenant complained that water drips down when it is raining. There are 3 contributing factors for this leak (photos 1,2)</p> <ol style="list-style-type: none"> 1. Poor window installation onto the felt roof - by not providing enough slope per manufacturers advice or damage in flashing. 2. The Velux window frame shows signs of damage due to a longstanding, ongoing leak. 3. The Velux seal may be broken and has to be replaced. Replacing the damaged parts would be costly due to the Velux window's age, and due to the window frame's poor condition, we cannot guarantee the leak would be resolved. <p>The Velux window in the kitchen, the seal may be broken and has to be replaced. Replacing the damaged parts would be costly due to the Velux window's age (photo 3).</p>

Location	Ref	Recommendation	Page	Priority
<u>xxxxx</u>	1	The damaged and leaking Velux windows have to be replaced and fitted correctly according to the instructions of the manufacturers to have at least a 20-degree slope. Due to the age of these windows, it would be difficult to find parts for the possibility of repair	11&14	
	2	Box-gutter will need to be fixed to accommodate the correct discharge of drainage water.	11 15	
	3	Sash windows will need handles for ease of operating, although this is a minor issue and can be done by anyone. These sash windows will need to be repaired and painted externally as existing paint is peeling off and will cause the timber to rot	12	
	4	Bathroom floor tiles and bath panel will need to be removed and redone properly. New WBP plywood needs to be fitted on the floor. Ditra matting and self-levelling compound. We recommend installing a good quality linoleum on the floor and the bath panel as this type of properties will always have movement, and tiles are not always the best material for this!	12

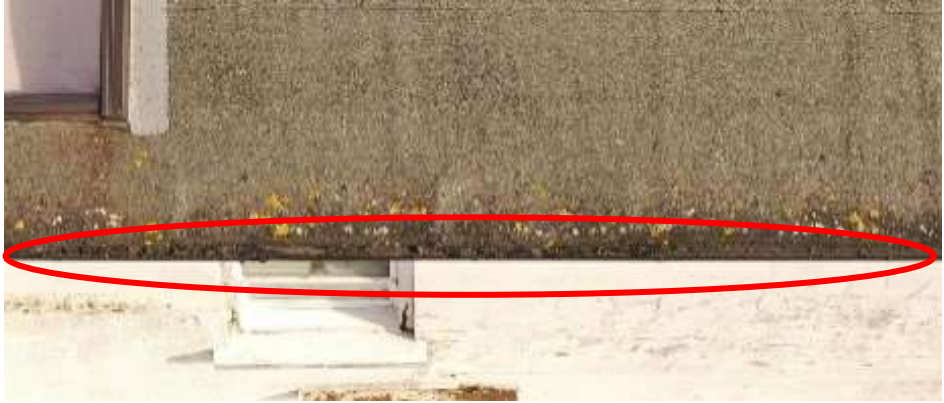
<p>DRO. 4 (VIS. E)</p>	<p>Gutters and box-gutter require to be cleaned in these locations (photos 1,2,3).</p>	<p>2</p>
<p>Photo 1</p>

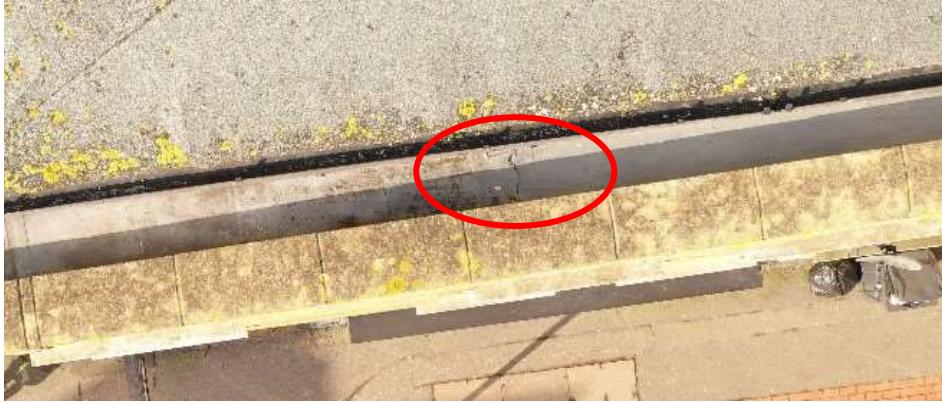
<p>DRO. 5 (VIS. I)</p>	<p>There is an insufficient covering of the box-gutter between the parapet wall and the mansard roof at xxxxx. The recent repair works were poor, and the rubber covering is cracked in many places and starting to peel off.</p>	<p style="text-align: center;">2</p>
<p>Photo 1</p>

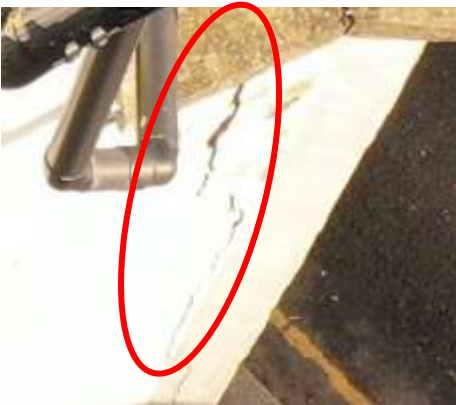
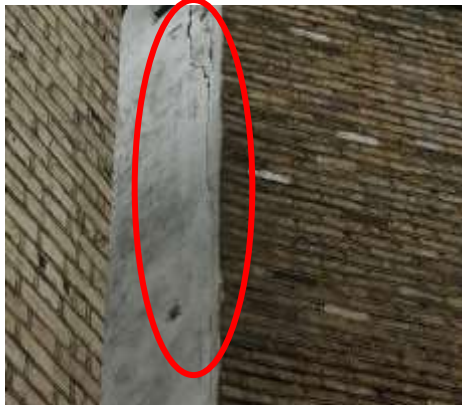
<p>DRO. 7</p>	<p>There is a visible crack in the external rendered wall on the left-side elevation from the property's Church Rd standpoint. (photo 1,2).</p>		<p style="text-align: center;">2</p>
<p>Photo 1</p>
