Roof and Rain Water Drainage System Maintenance Report

Date:	11/25/2020
Address:	XXXXXXXXXX XXXXX
Inspection No:	113
Type:	Residential
Client:	XXXXXX XXXXXXXXXXXX XXX

Section 5: Details of completed works

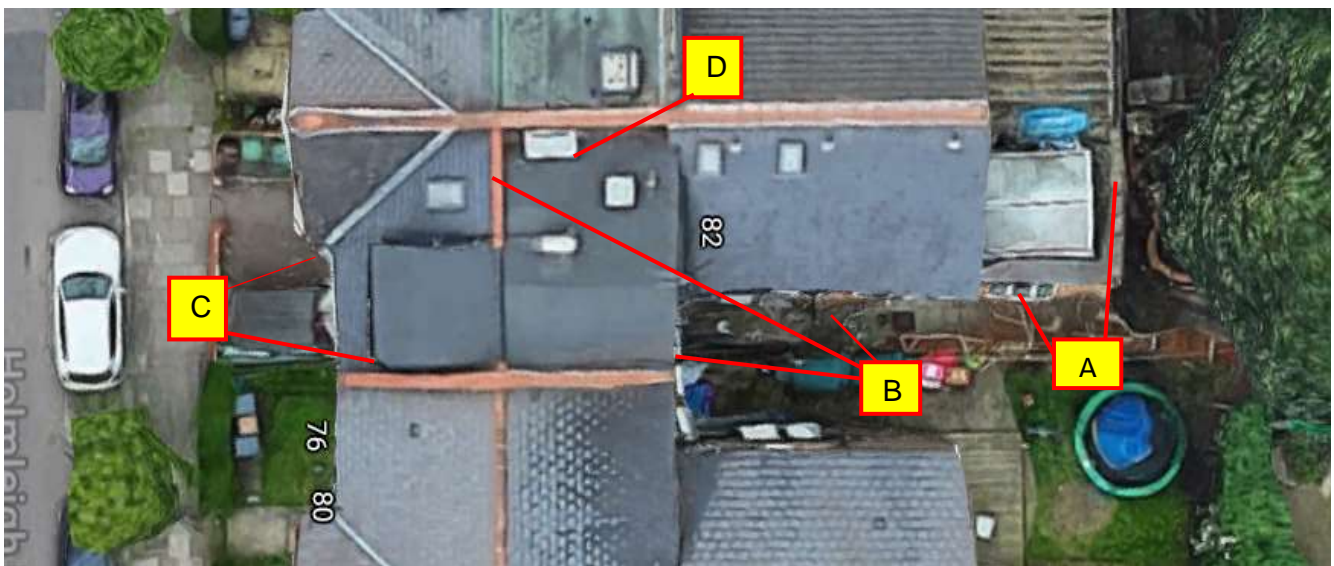
To carry out cleaning of the areas mentioned including flashing the downpipes.

To repair the disconnected downpipe

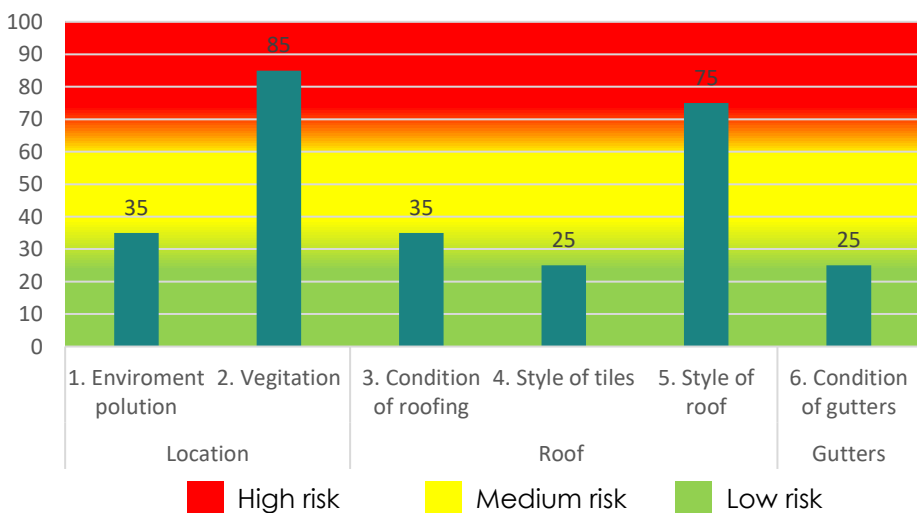
Risk evaluation for

- Points of High Risk**
- 2. Large tree in very close proximity at the back of the property. Some signs of growing moss.
 - 5. Flat roof of one-story rear extension.
