Roof and Rain Water Drainage System Survey Report

Master Property Care Ltd

Date:	3/8/2021
Address:	XXXXXXXXXXXXXXXXXXXX
Inspection No:	125
Type:	Residential-Commercial
Client:	XXXXXXX XXXXXXX XXXXXX

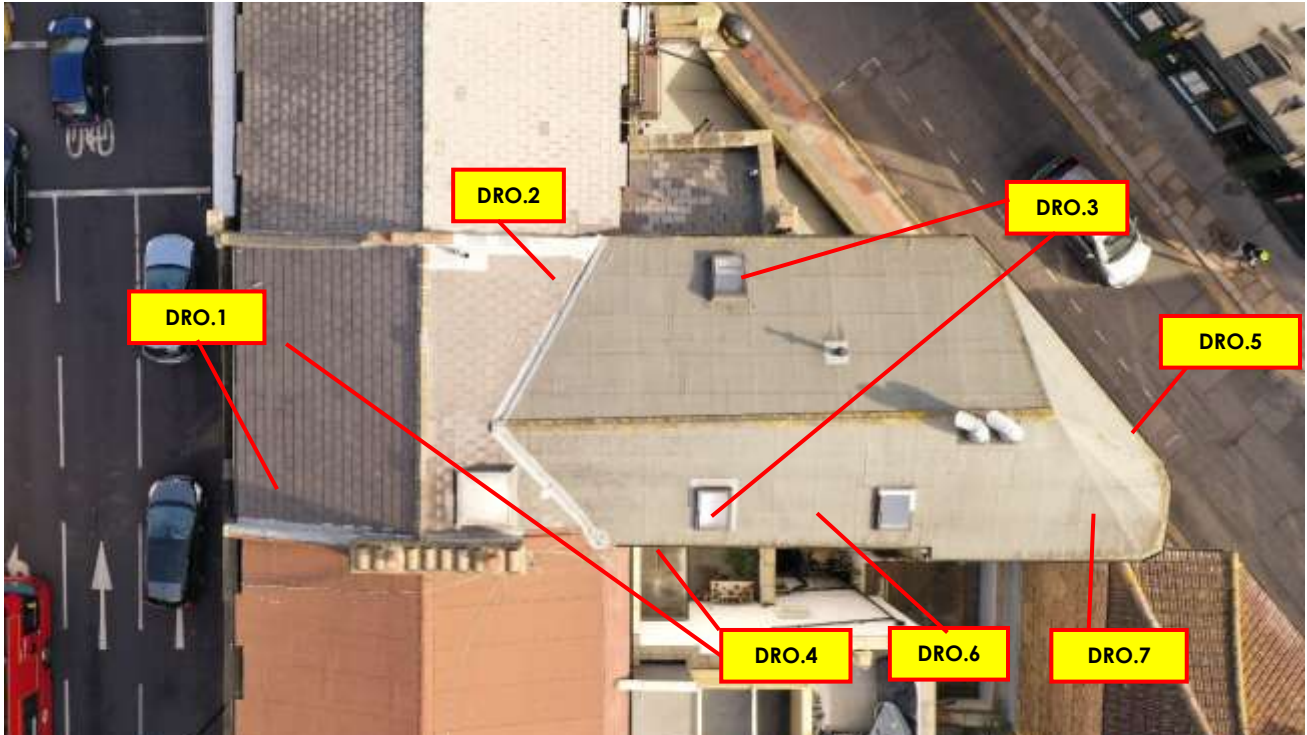
Table 12

<p>DRO. 1 (F)</p>	<p>The box gutter located on the right side of the neighboring property is also draining into the same downpipe. It may not be sufficient to accommodate a large flow of rainwater from both properties and may cause an overflow responsible for water penetration into xxxxx. (photos 1,2).</p>	<p style="text-align: center;">3</p>
<p>Photo 1</p>
